RARITAN RIVER BASIN
ROCK BROOK, SOMERSET COUNTY
NEW JERSEY

SKILLMAN DAM

N J 00018

PHASE 1 INSPECTION REPORT NATIONAL DAM SAFETY PROGRAM

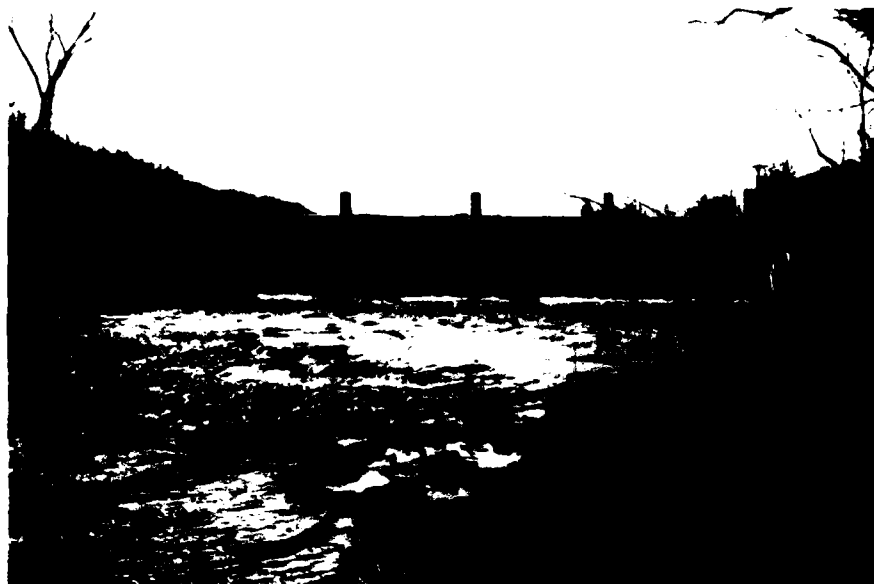
PHOTO 1

SPIILLWAY

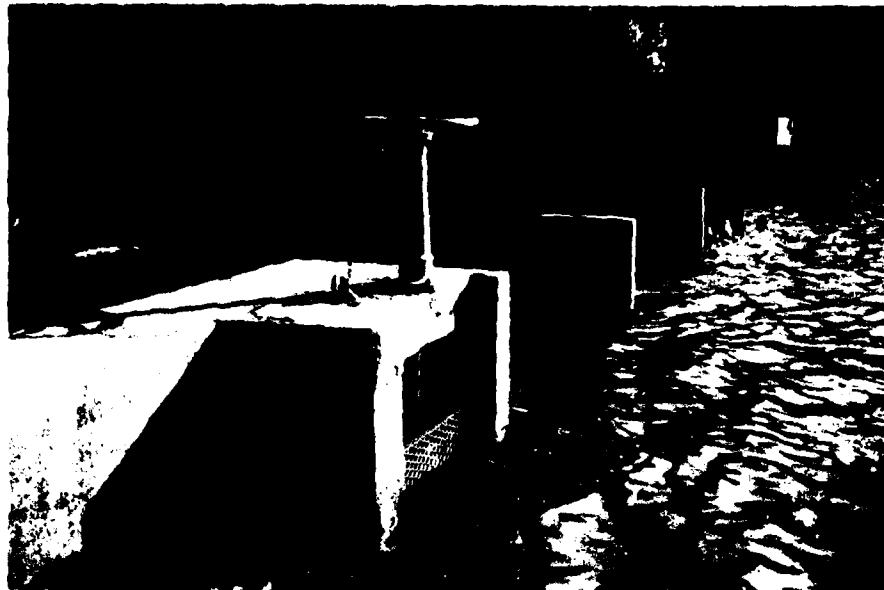
PHOTO 3

OUTLET WORKS OPERATING MECHANISM

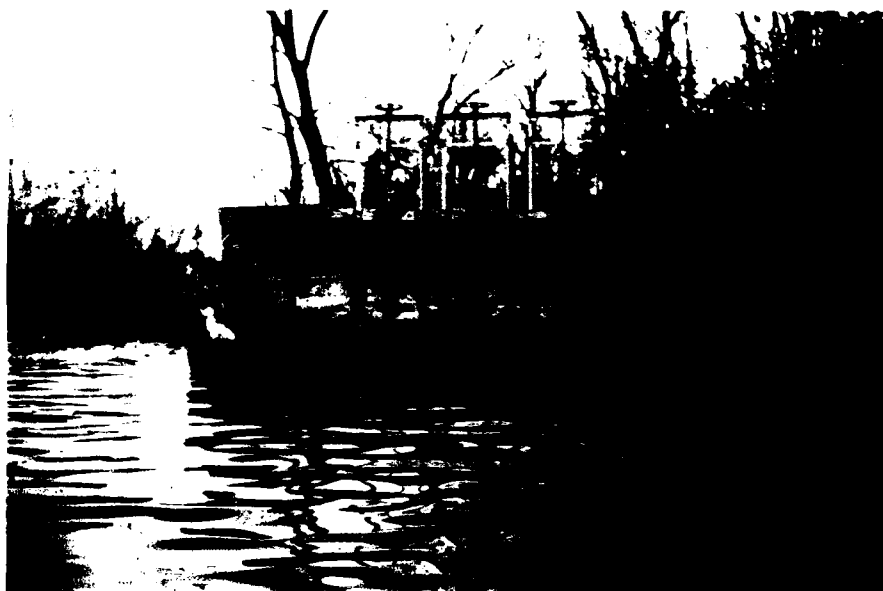
PHOTO 6

Four outlet control stems were observed. Three were located at the southern concrete abutment and one at the northern abutment. The north outlet is reported to be the only one operable. A significant amount of rust was observed on the frames and stems of the south outlet controls.

ABANDONED GATE CONTROLS ADJACENT TO SOUTH END OF SPILLWAY

The three abandoned outlets at the south end of the spillway should be further investigated in the near future to determine the need for and feasibility of restoration to functional use. The investigation should include recommendations for proper measures to restore or permanently abandon the outlets.
